## 406 MHz ELTs continue to demonstrate deficiencies

**By Kevin Psutka, COPA President and CEO**

The Transportation Safety Board of Canada (TSB) issued its investigation report <http://www.tsb.gc.ca/eng/rapports-reports/aviation/2011/a11w0151/a11w0151.asp> on March 20, 2013 into a 2011 accident involving a Cessna 208B Caravan.

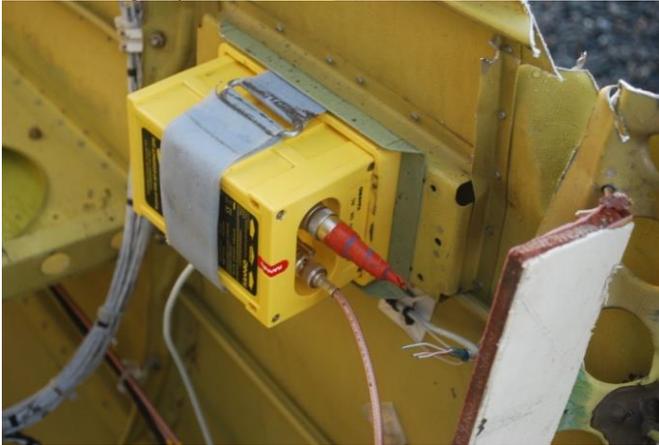
The ELT rests within a raised box structure around the perimeter of the mounting tray, and is secured by a fabric strap featuring a hook and loop (Velcro) system. When the strap is tight, the ELT is firmly held in the mounting tray box ([Photo 1](#)).

**Photo 1.** Mounted ELT in C-GATV

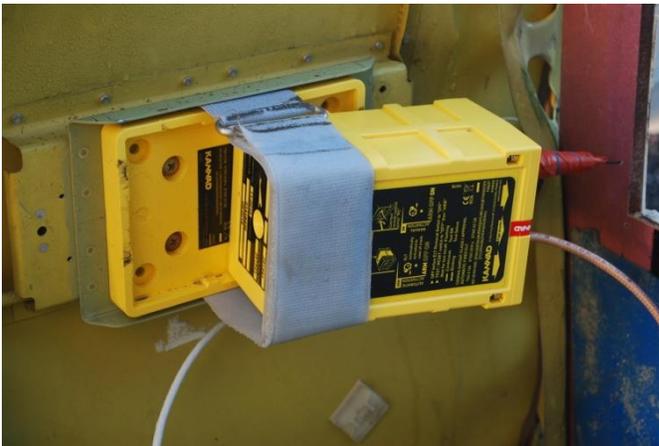
**Photo 2.** ELT sliding under loose strap

Field examination of the ELT and mounting bracket in C-GATV revealed that the retention strap was loosely fastened and that it was possible to slide the ELT under the strap and back into its mount. The unit could easily be removed in the same manner. After adjusting the strap by shortening it  $\frac{3}{4}$  inch, the strap was tight around the ELT, which was then firmly secured in the bracket. The ELT then could not be manually removed without loosening the strap.

Due to a loosely fastened hook and loop retention strap on the ELT installation, the ELT was ejected from its mounting tray during the impact. Since instructions do not describe a method for determining the required degree of tightness to retain the ELT in its mount, the installer's own judgment is relied upon to determine this. As a result, a wide variation in the quality of installation of ELTs that are retained by this method could increase the possibility of inadequate retention.

Installation instructions for the ELT did not provide a means of determining the necessary degree of strap tightness to prevent the ELT from being ejected from its mount during an accident. Resultant damages to the ELT and antenna connections could preclude transmission of an effective signal, affecting search and rescue of the aircraft and occupants.
